Geomorphology Study of the Fargo, ND & Moorhead, MN Flood Risk Management Project

US Army Corps of Engineers
St. Paul District
180 5th St E
Suite 700
St. Paul, MN 55101

October 25, 2012

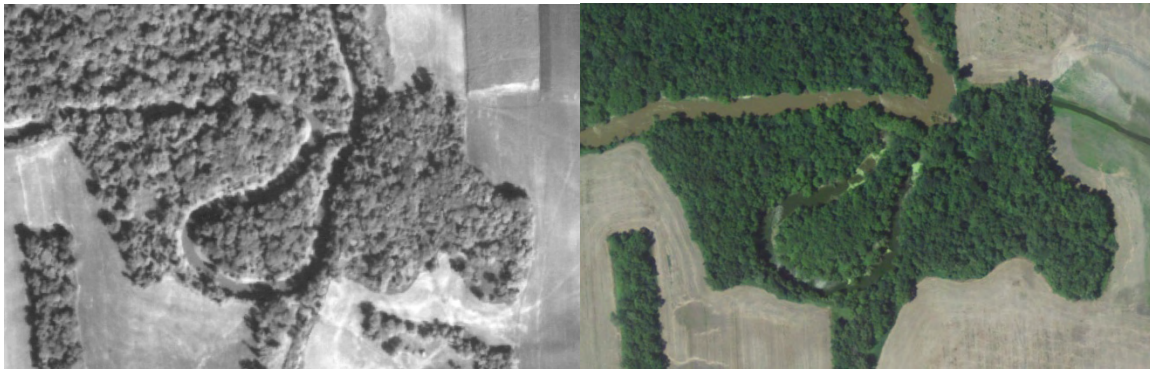
Figure 6-8. Abandoned Meander, Sheyenne River - 8 (left – 1962, right – 2010)

significant migration of the channel. However, as previously discussed, channel migration is likely occurring, albeit at a relatively low rate of a few inches per year. The cohesive nature of the clay soils (which provides resistance to erosion) combined with the low energy gradient of the stream channels (which results in low erosion potential), prevents significant erosion from occurring. The erosion that is occurring, is taking place at the toe of the bank failure along the outside of the meander bend. The long-term erosion rate for the toe of the bank failure is slightly greater than the long-term deposition rate for the top of the bank. Along the inside of the meander bend, deposition along the top of bank is slightly greater than erosion along the toe. This results in the relatively low rates of channel migration for the study streams. Based on the available data, the evolution of the cut-offs shown in Figure 6-8, Figure 6-9, and Figure 6-10 appears to progress very slowly; however as the neck between the upstream and downstream side of the bends narrow, it is possible that the bank failures and the significant flooding that occurs on a regular basis provide the mechanism or catalyst for the final cut-off to occur. It would be expected that in unprotected areas this natural evolution would continue as before; however, in the protected areas, the possible mechanisms that cause the final cutoff to occur (bank failure and flooding) would be reduced and/or eliminated, thereby slowing the final cut-off of the bend(s).

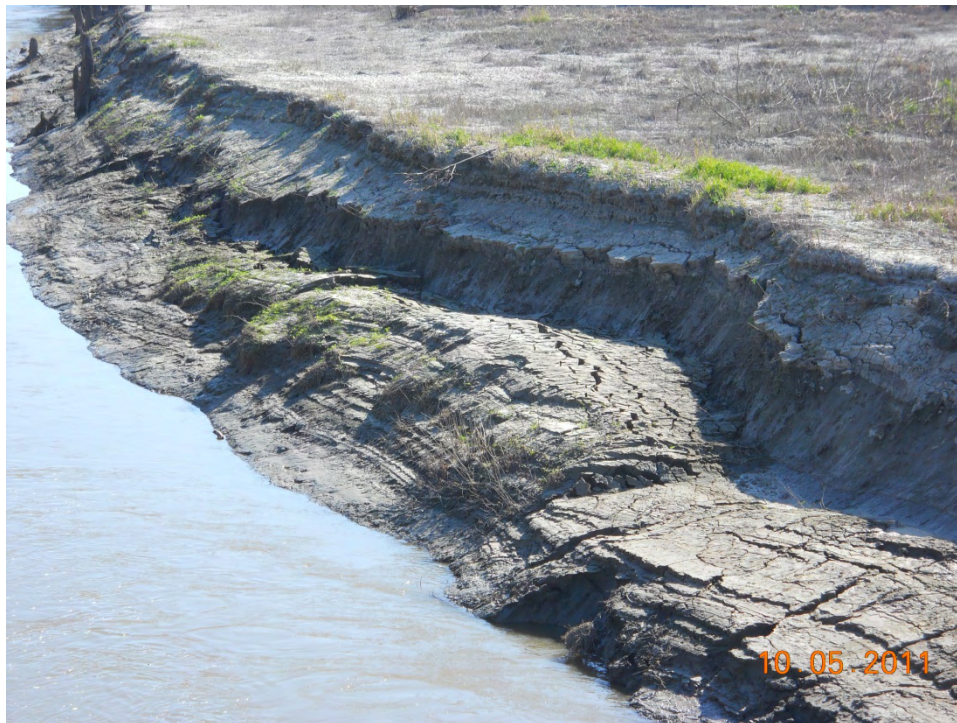
Figure 6-12. Bank Slumping along Sheyenne River - 1

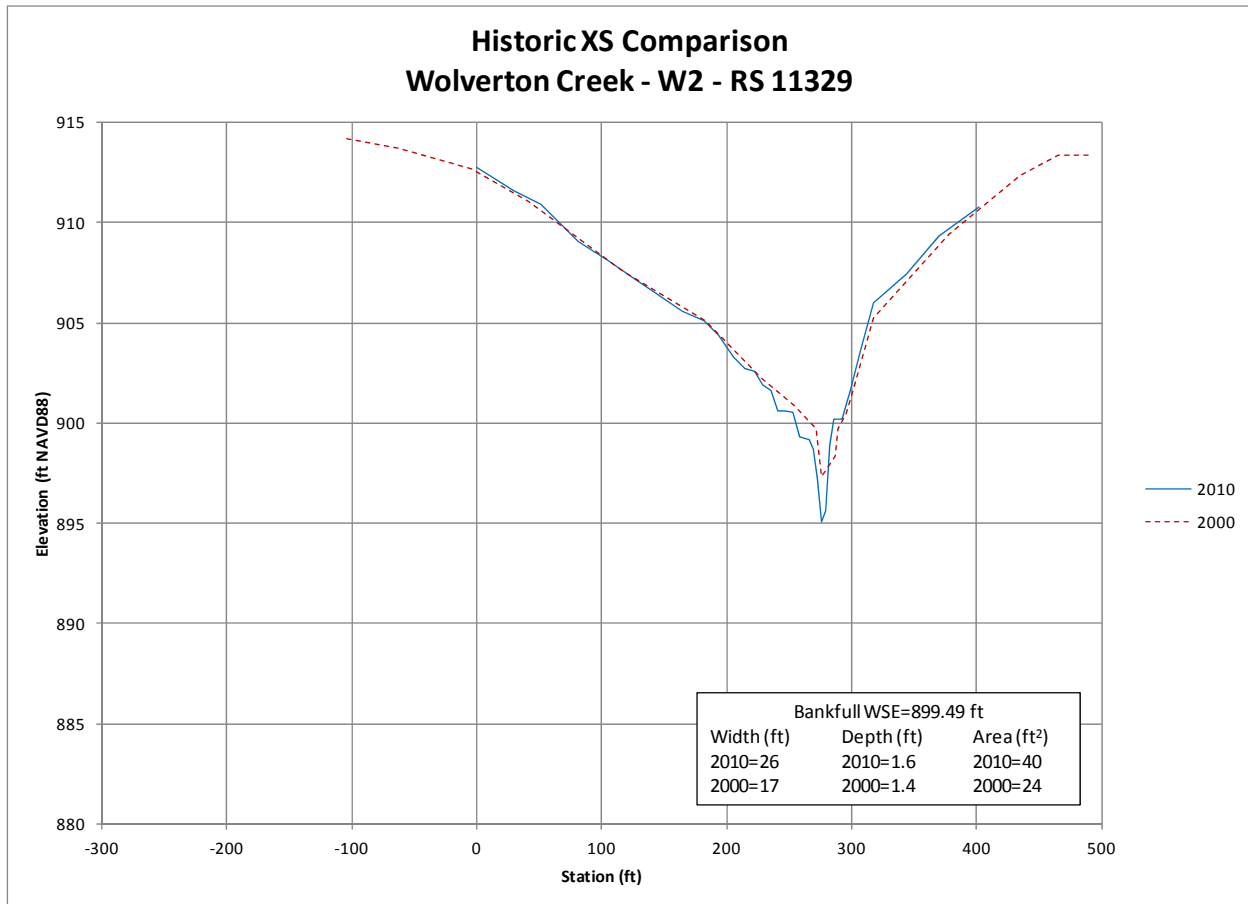
Figure 6-30. Historic Cross Section Comparison for Location W2

Figure 6-30 shows that Wolverton Creek cross section W2 has experienced channel widening at the bankfull elevation between 2000 and 2010. It appears that a geotechnical bank failure occurred along the left bank and is reflected in the 2010 survey, resulting in an increase in bankfull top width. It is also noted that the thalweg elevation decreased approximately 2.3 feet between 2000 and 2010. One possible explanation is that this decrease is the result of anthropogenic changes to the watercourse intended to increase the flow capacity of the channel.

The historic cross section comparisons indicate that, with the exception of localized impacts from human caused modifications, there have been no significant changes to the channel geometry over time. While certain individual cross sections were consistently widening or narrowing over time, reach wide or river wide trends in bankfull top width changes are not occurring. Of the 42 historic cross sections examined for changes in bankfull top width, 3 were narrowing, 2 were widening, and 37 either did not have a trend, could be discounted based on human alterations near the cross section, or could not be assessed due to poor quality survey data. In the same respect, while certain individual cross sections were consistently degrading, reach wide or river wide trends in hydraulic depth changes are not occurring. Of the 42 cross sections evaluated, only 5 appear to be degrading. The remaining 37 cross sections either did not have a top width trend, could be discounted based on human alterations near the cross section, or could not be assessed due to poor quality survey data. The historic cross section comparison results suggest that the channels within the project area are stable and that flow changes resulting

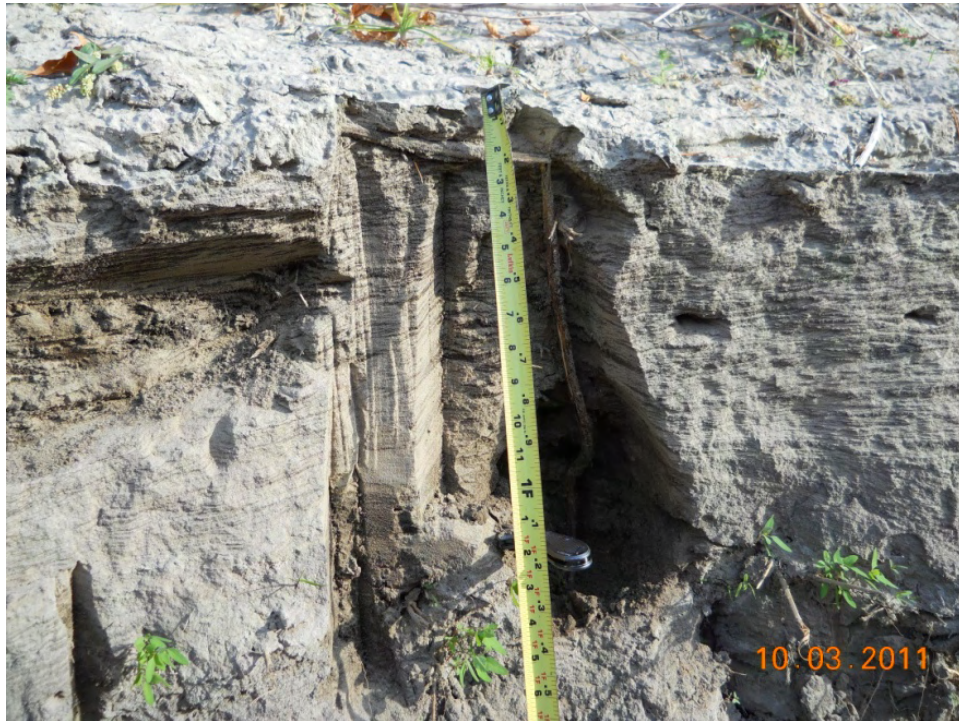
Figure 9-1. Sheyenne River Overbank Sand Deposits Interbedded with Clays and Silts

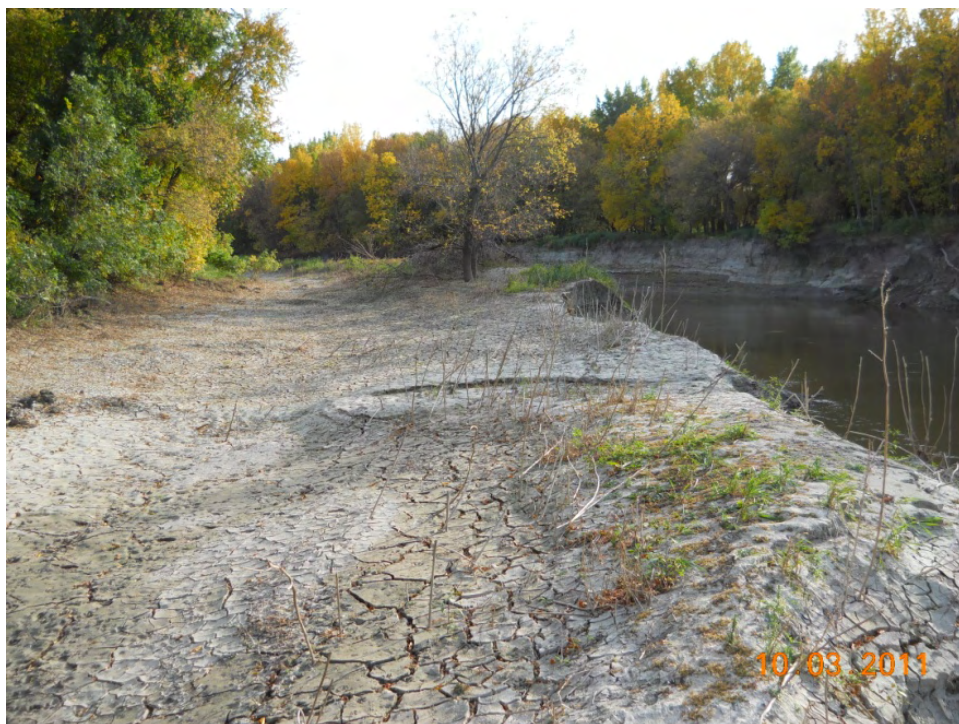
Figure 9-2. Natural Levee Formed by Sand Deposition along the Sheyenne River

Although significant sedimentation does not appear to be occurring within the channels, sediment deposits were observed in the overbank areas adjacent to the channels. For the Sheyenne River, the overbank deposits included a high proportion of sand-sized material interbedded with silt- and clay-sized material as seen in Figure 9-1. The majority of the sand deposits were located at or near the top of the bank and often form a natural levee features as seen in Figure 9-2. Further away from the channel, the overbank deposits consisted of mainly

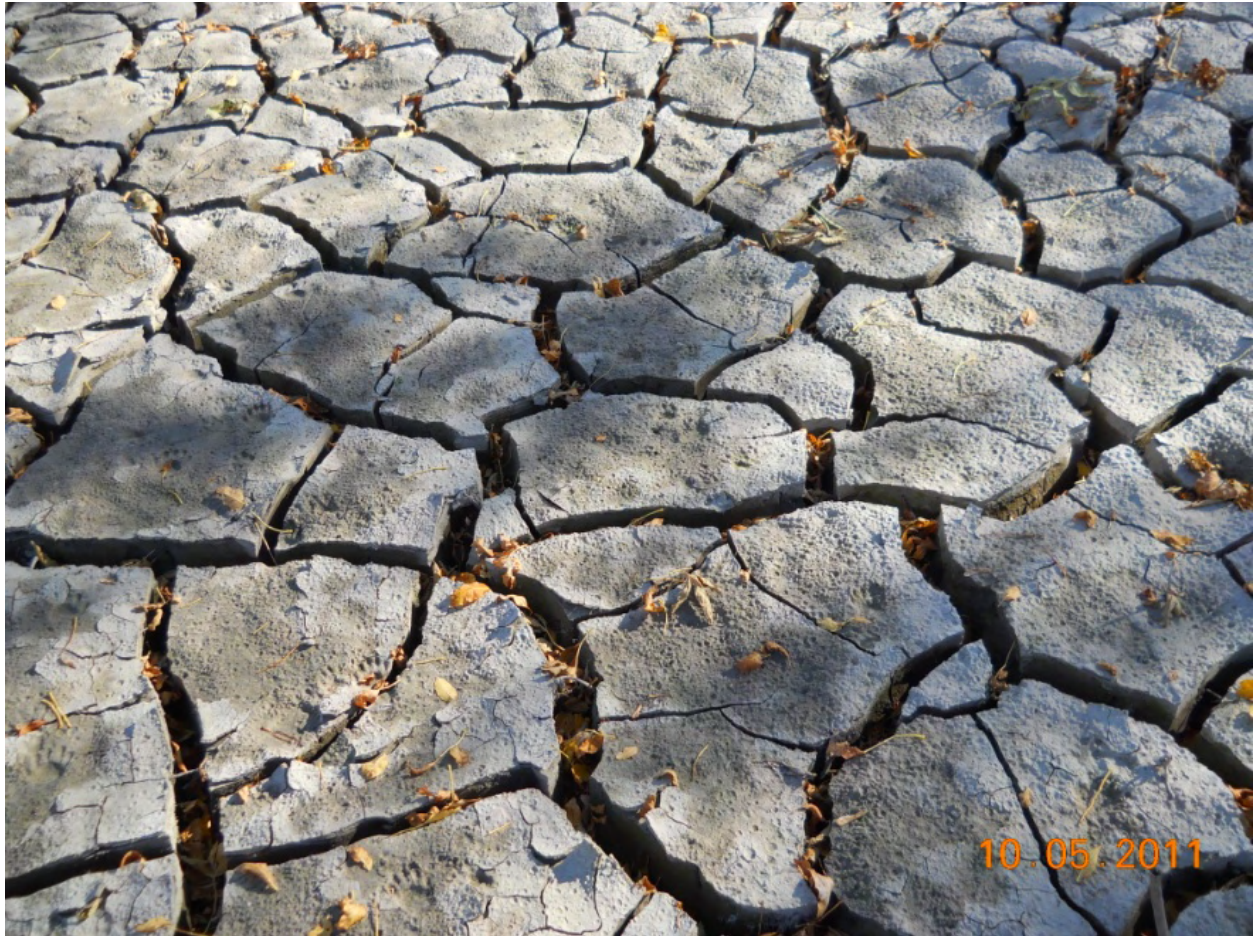
Figure 9-3. Silt and Clay Deposits in the Overbank Area of the Sheyenne River

silts and clays as seen in Figure 9-3. For the remainder of the study streams, the overbank deposits consisted of mainly silts and clays.

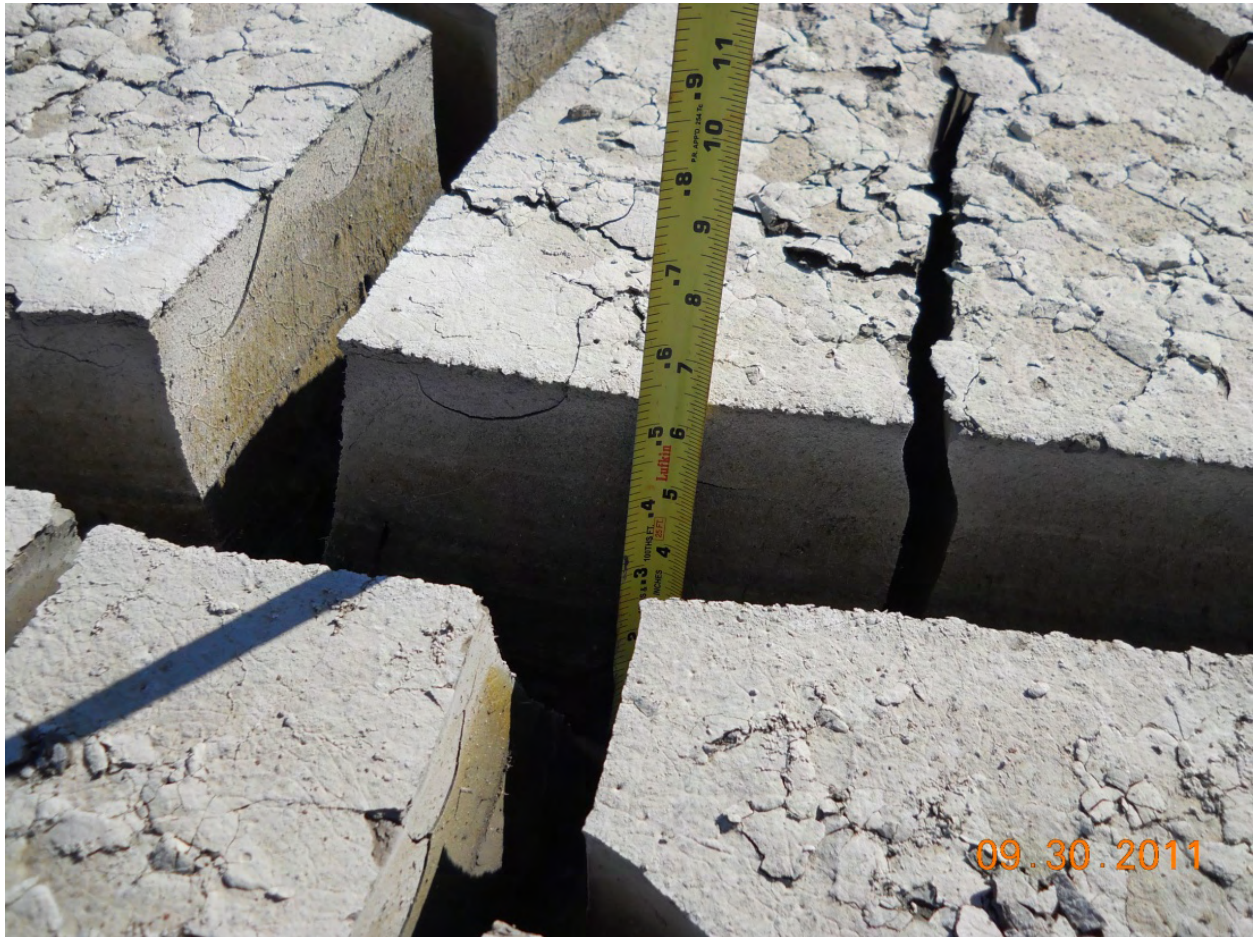
Figure 9-4. Clay and Silt Overbank Sediment Deposits along Maple River - 2

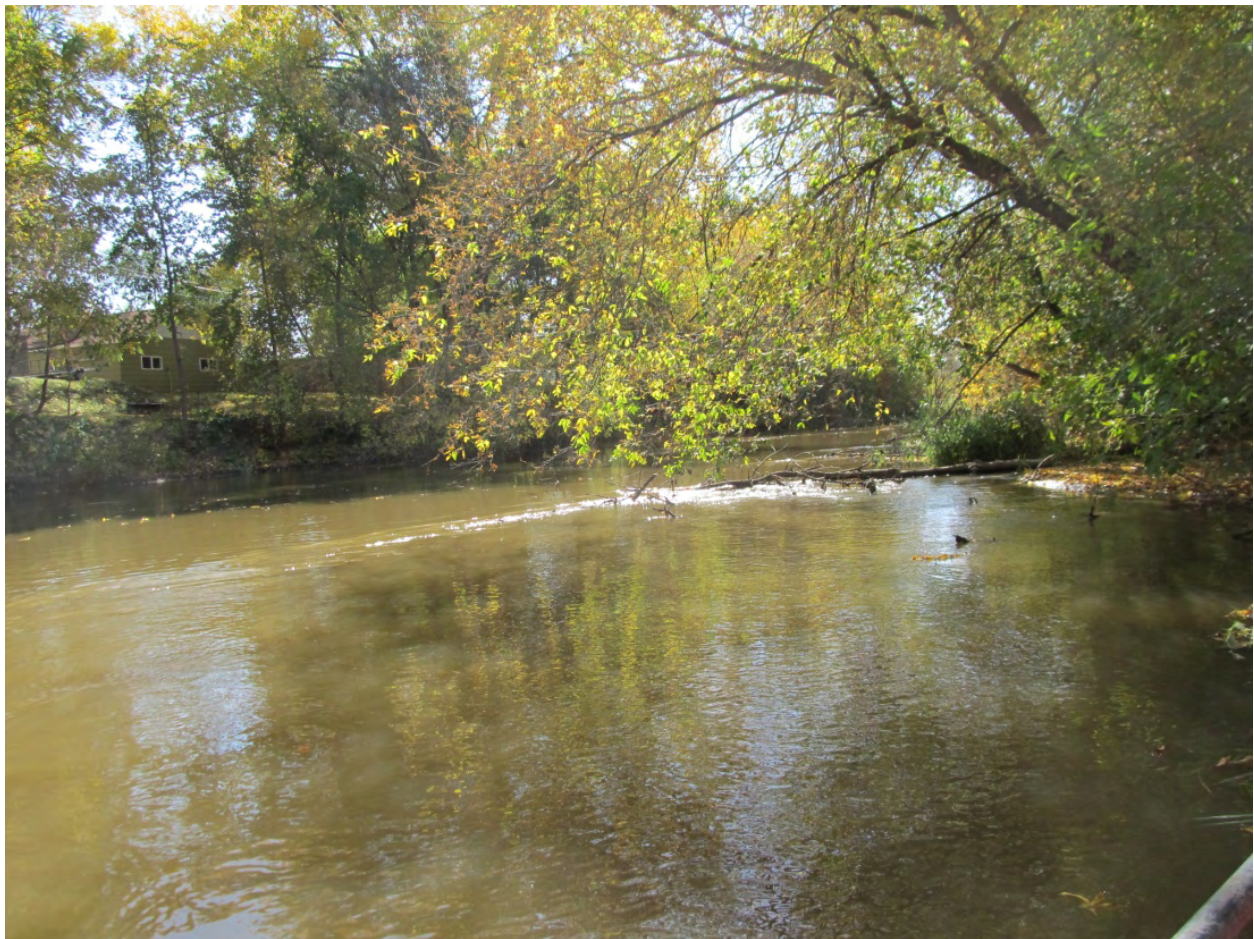
Figure 9-6. Riparian Vegetation Conditions along Sheyenne River - 5

Moderate changes to riparian vegetation conditions are expected as a result of the FCP and LPP alignment alternatives. For areas protected by the diversion, riparian vegetation will not be subject to extended periods of inundation by floodwaters nor significant burial by overbank sediment deposits. Additionally, damage from ice flows is expected to be reduced. The trees and shrubs would be expected to encroach on the channel compared with current conditions and be less impacted by bank slumping. An example of the riparian conditions that might be expected to occur along those reaches protected by the diversion alignment is shown in Figure 9-6, which is a photo that was taken along Sheyenne River Reach 5. Reach 5 is currently protected from flooding by the West Fargo Diversion.

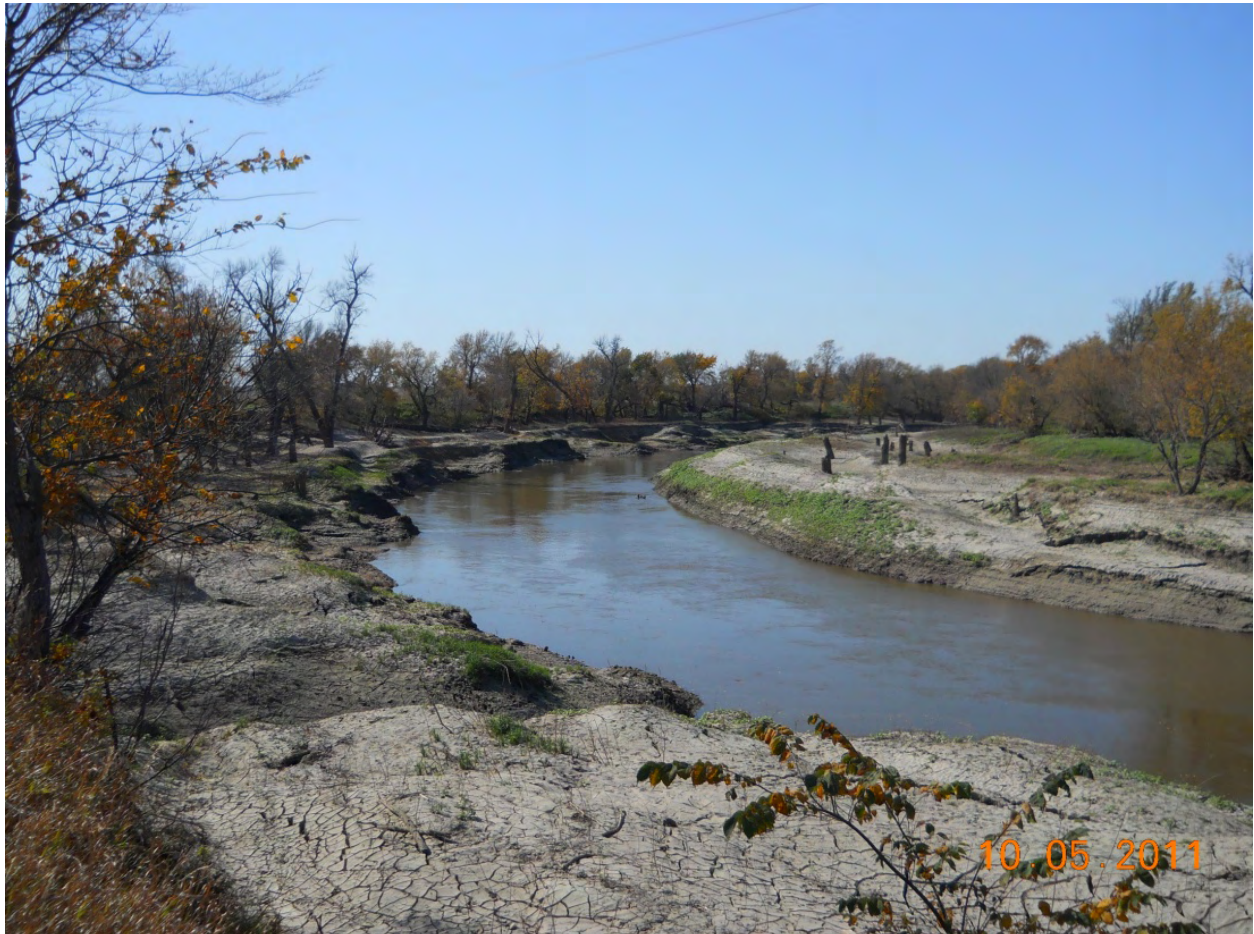
Figure 9-7. Riparian Vegetation Conditions along Sheyenne River - 1

For the reaches upstream of the LPP diversion channel within the floodwater staging area, the riparian vegetation will be subject to greater periods of inundation and greater burial by overbank sediment deposits. However, according to the St. Paul District (USACE, 2012) the majority of the floodplain species are adapted to inundation by floodwaters and partial burial by sediment during the dormant season. However, if the inundation by floodwaters extends into the growing

season, they are likely to be stressed, which would make them more susceptible to disease and insects. Additionally, there could be greater damage from ice flows. As a result, the trees and shrubs may tend to retreat away from the channel. If this occurs, seasonal grasses or other vegetation types better suited to such conditions will be more prominent in these areas. The increased rate of bank slumping would also be expected to result in fewer trees in close proximity to the channel. An example of the riparian vegetation conditions that might be expected within the staging areas upstream of the diversion is shown in Figure 9-7, which is a photo that was taken along Sheyenne River Reach 1 following the spring and summer flood of 2011.

The impacts on the channel morphology as a result of changes in the riparian vegetation conditions are expected to be minimal. There does not appear to be any significant increase in erosion resistance for banks that have greater root density or vegetative cover. The slippage surface of the rotational bank slumps is typically below the depth of root penetration. Therefore, the riparian vegetation generally does not add sufficient resistance to prevent or reduce movement along the slippage surface. In fact, the added weight of the trees located on the slumping portion of the bank may tend to accelerate movement of the slumping material.
